Manhole Inspection Summary

Manhole # S17I__029MH

Insp Date: **4/7/09 8:30 AM**

Location Address: **2432 W BALTIMORE ST**

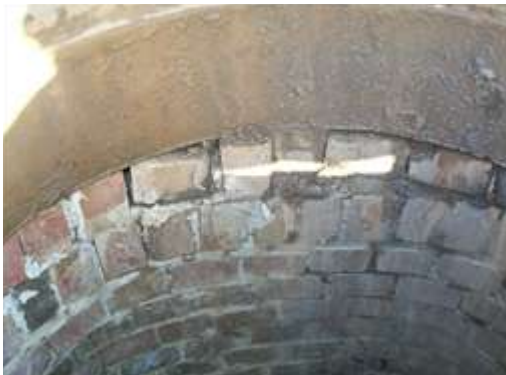
Defect 2

Frame Offset: **0** (in.) Condition: ☐ Sound ☐ Cracked ☒ **Leaks**

EVIDENCE OF INFILTRATION DUE TO SHEETING - FRAME LEAKS

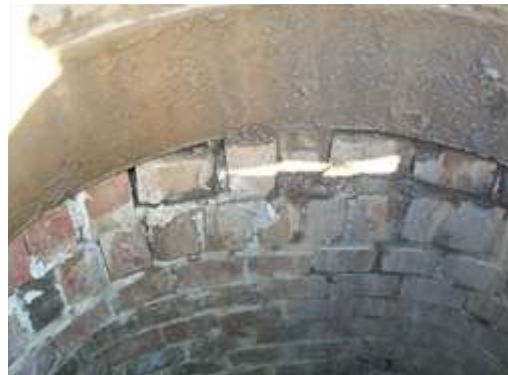
Defect 1

Condition: ☐ Sound ☐ Cracked ☐ Root Intrusion ☐ Loose Brick ☒ **Deteriorated**

Infiltration: ☐ None ☐ Joint ☐ Cracks ☐ Mortar ☐ Roots ☒ **Wall**

DETERIORATED CHIMNEY - MISSING MORTAR

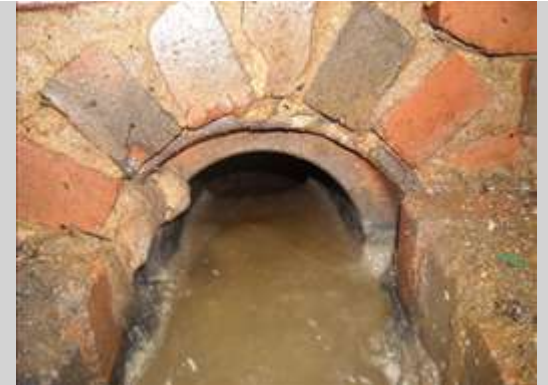
12 O'Clock Outflow

8 in. Circular Gravity Sewer
Pipe Out @ 12 O'Clock

Pipe Height: (in.) Direct (Angled)
Pipe Material: **Clay** ☐ Pipe Lined
Invert Depth: **8.01** (ft.) Flow Characteristics: **Slow**
Deposits: ☒ None ☐ Mud ☐ Sludge ☐ Debris ☐ Grease
Silt Depth: (in.) Deposits Extent:
Infiltration: **None** Pipe Seal Cond: **Sound**

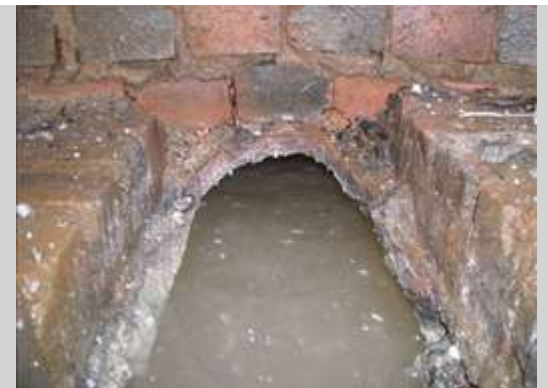
6 O'Clock Inflow

Condition: ☐ Sound ☐ Cracked ☐ Root Intrusion ☐ Deteriorated ☐ Leaks ☒ **Debris**

GREASE IN CHANNEL
